EXAMINATION OF THE SURVEYOR 3
SURFACE SAMPLER SCOOP RETURNED
BY THE APOLLO 12 MISSION

R. F. Scott and K. A. Zuckerman

1971

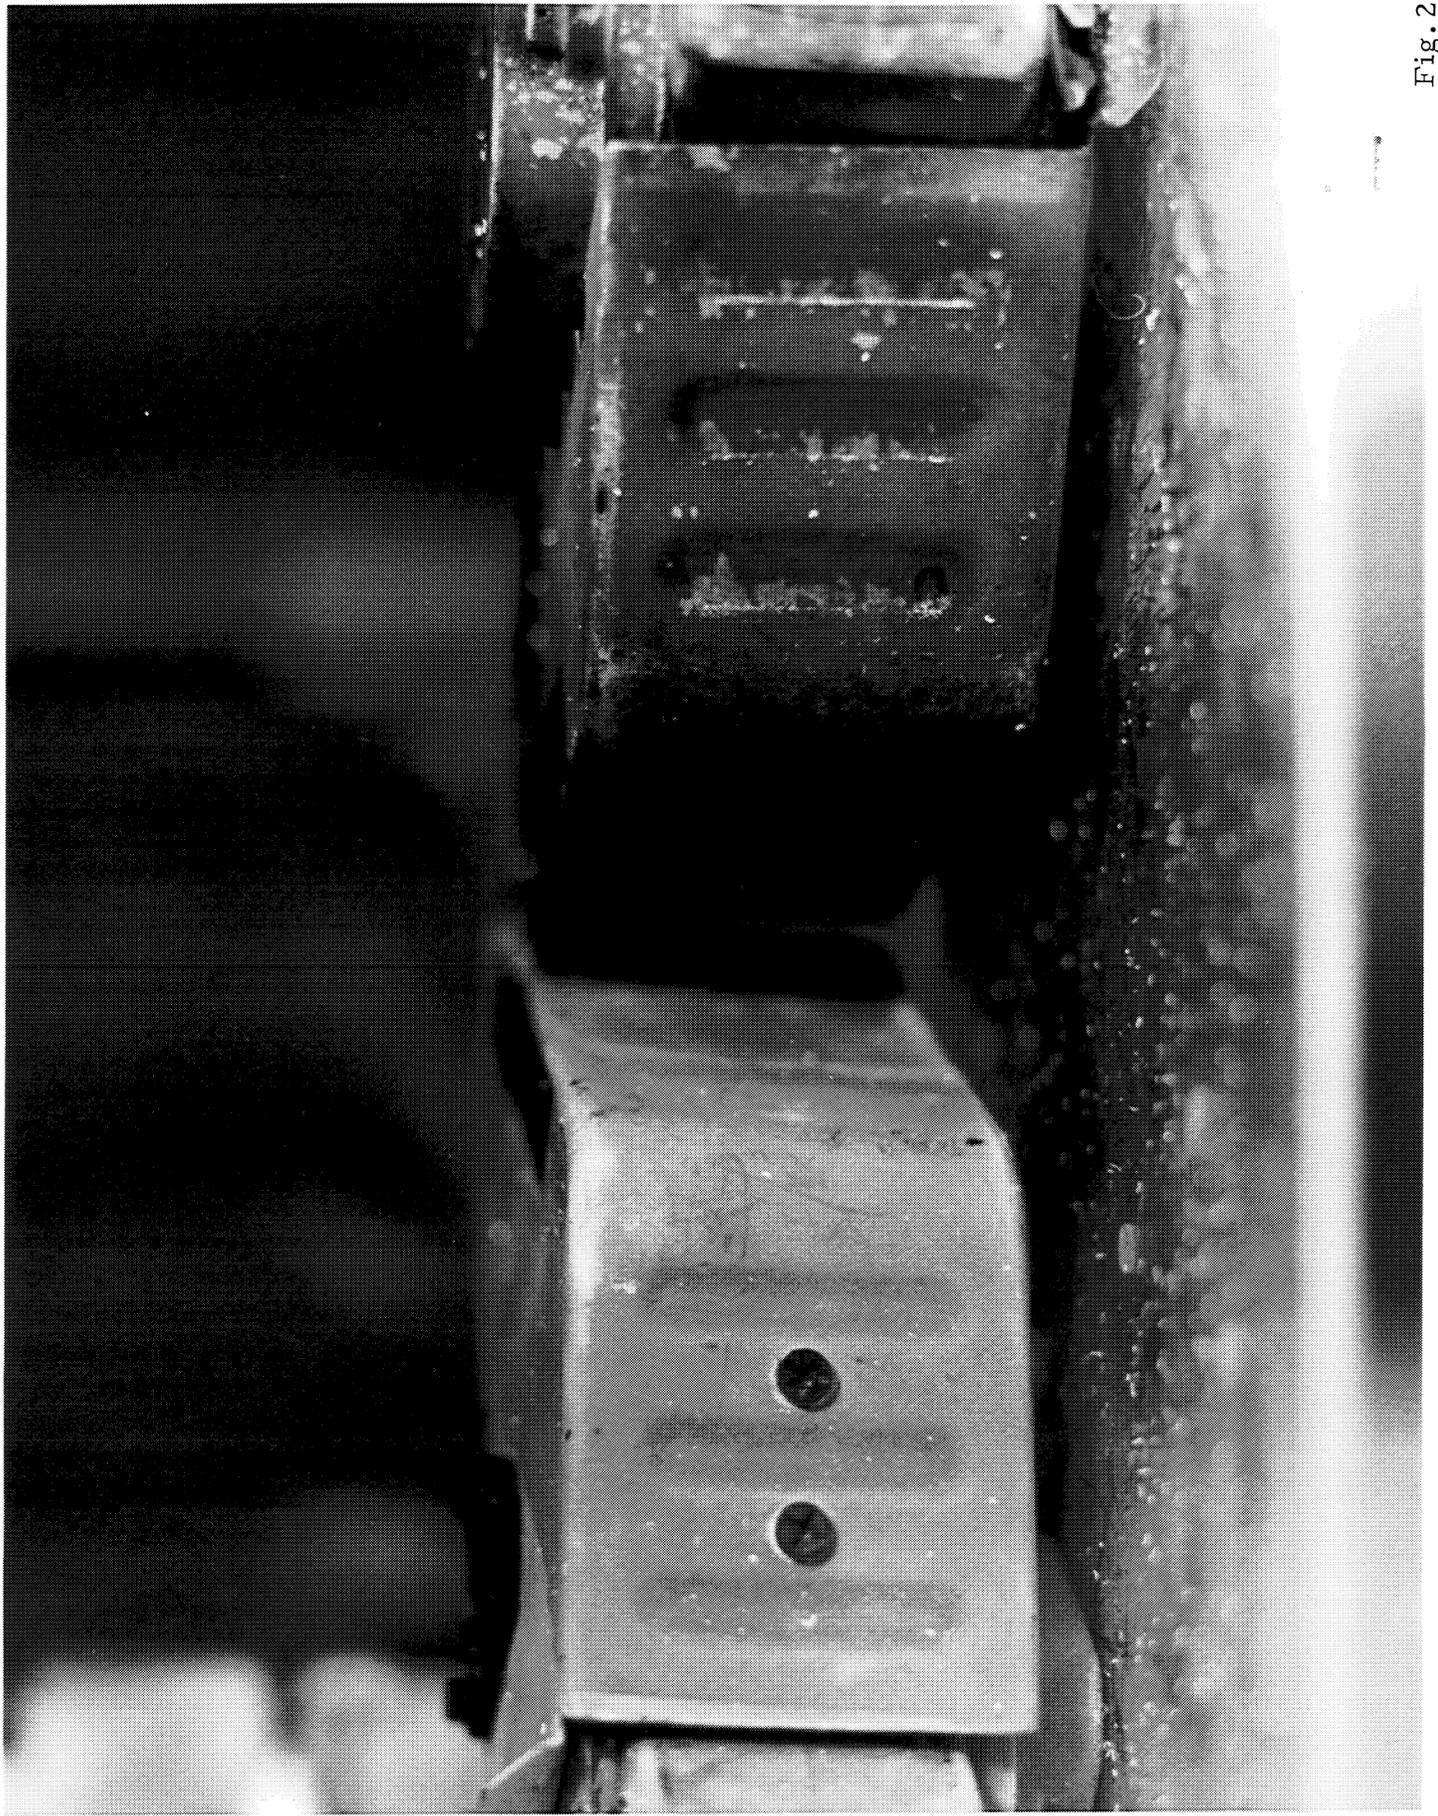
The most striking change in the appearance of the samplers can be observed by comparing the tops of the two scoops in Figs. 20 and 21. The brown coloration of the returned scoop is deeper on the upper surface, and this is made even more apparent by the photograph (Fig. 21) in ultraviolet illumination. At the bottom of the housing which covers the scoop door motor, a yellow region is seen in Fig. 21. This is probably due to irradiation of a spill of the epoxy coating which was applied to the terminals of the wires for protection, since it does not appear on the laboratory sampler to which no epoxy was applied. Alternatively, it may be the result of the irradiation of this part of the scoop which was altered by heating when the wires were soldered in place. The upper surface of both scoops is shown in Fig. 22 in which it is seen, as remarked earlier, that some protection to the paint was

probably afforded by patches of soil at the bottom corners of the grooves. It is likely that the lighter appearance of both scoops around the edges is due to abrasion during transport and handling.

The origin of the dark splotch (which is real) at the bottom of the left-hand groove of the returned scoop is not known. It is also not clear why the protection which it is surmised was offered by lunar soil collecting in the grooves is so clear-cut. If the brown coloration is a result of solar radiation, it might be expected that the brown coloration would shade gradually from the color in the completely shielded area into the appearance of the unprotected surface.

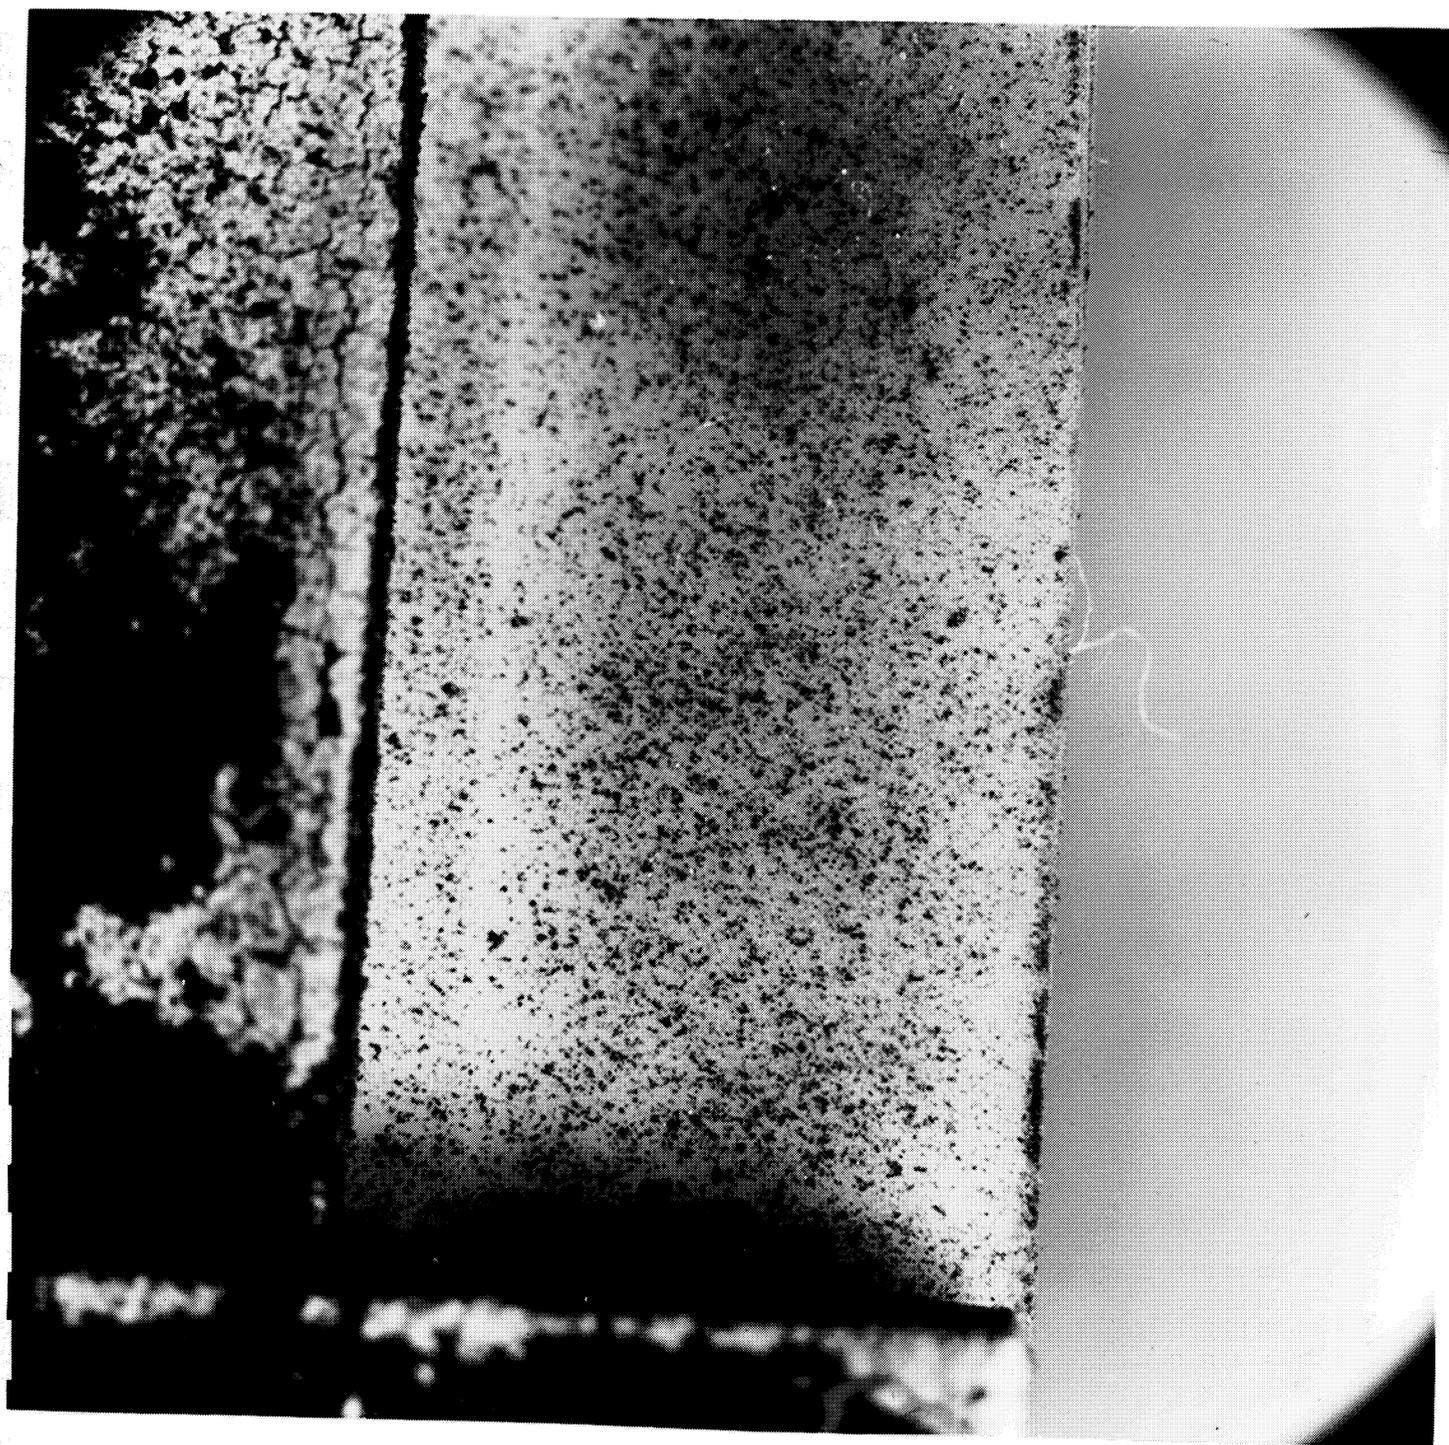
this change took place rather quickly on the lunar surface by referring to Fig. 2 which clearly indicates the same shading on the visible portion of the Teflon door after only 10 days on the lunar surface. The discoloration is also clearly apparent in Fig. 25, and to a lesser degree in Figs. 23 and 24. As with the color change of the paint, the discoloration of the Teflon probably resulted from its exposure to solar radiation.

A comparison between the bases of the scoop doors is shown in Figs. 23 and 24. In the case of the laboratory scoop, much of the paint was removed from the scoop door during the test in water-saturated soil; some of it was pulled off by stripping a piece of adhesive tape which was attached to the scoop base at one stage of testing. It is evident that the bonding of the paint to the resin of the scoop base is not very strong. In the returned scoop, on the right in Fig. 23, the pattern of crazing on the base is apparent, as is also the browning of the edges of the Teflon sealing the door. Once again, even though the base of the scoop was relatively protected from solar illumination it has also undergone the color change apparent in the previous photographs. In the portions of the glass-impregnated resins, which are revealed where the paint has chipped away from the scoops, little or no color change is obvious in either Fig. 23 or Fig. 24. This may be an indication that the paint was only removed in these areas during and following the return of the surface sampler to earth. The change in the appearance of the Teflon surface is shown in Fig. 25 for a comparison with the view of the

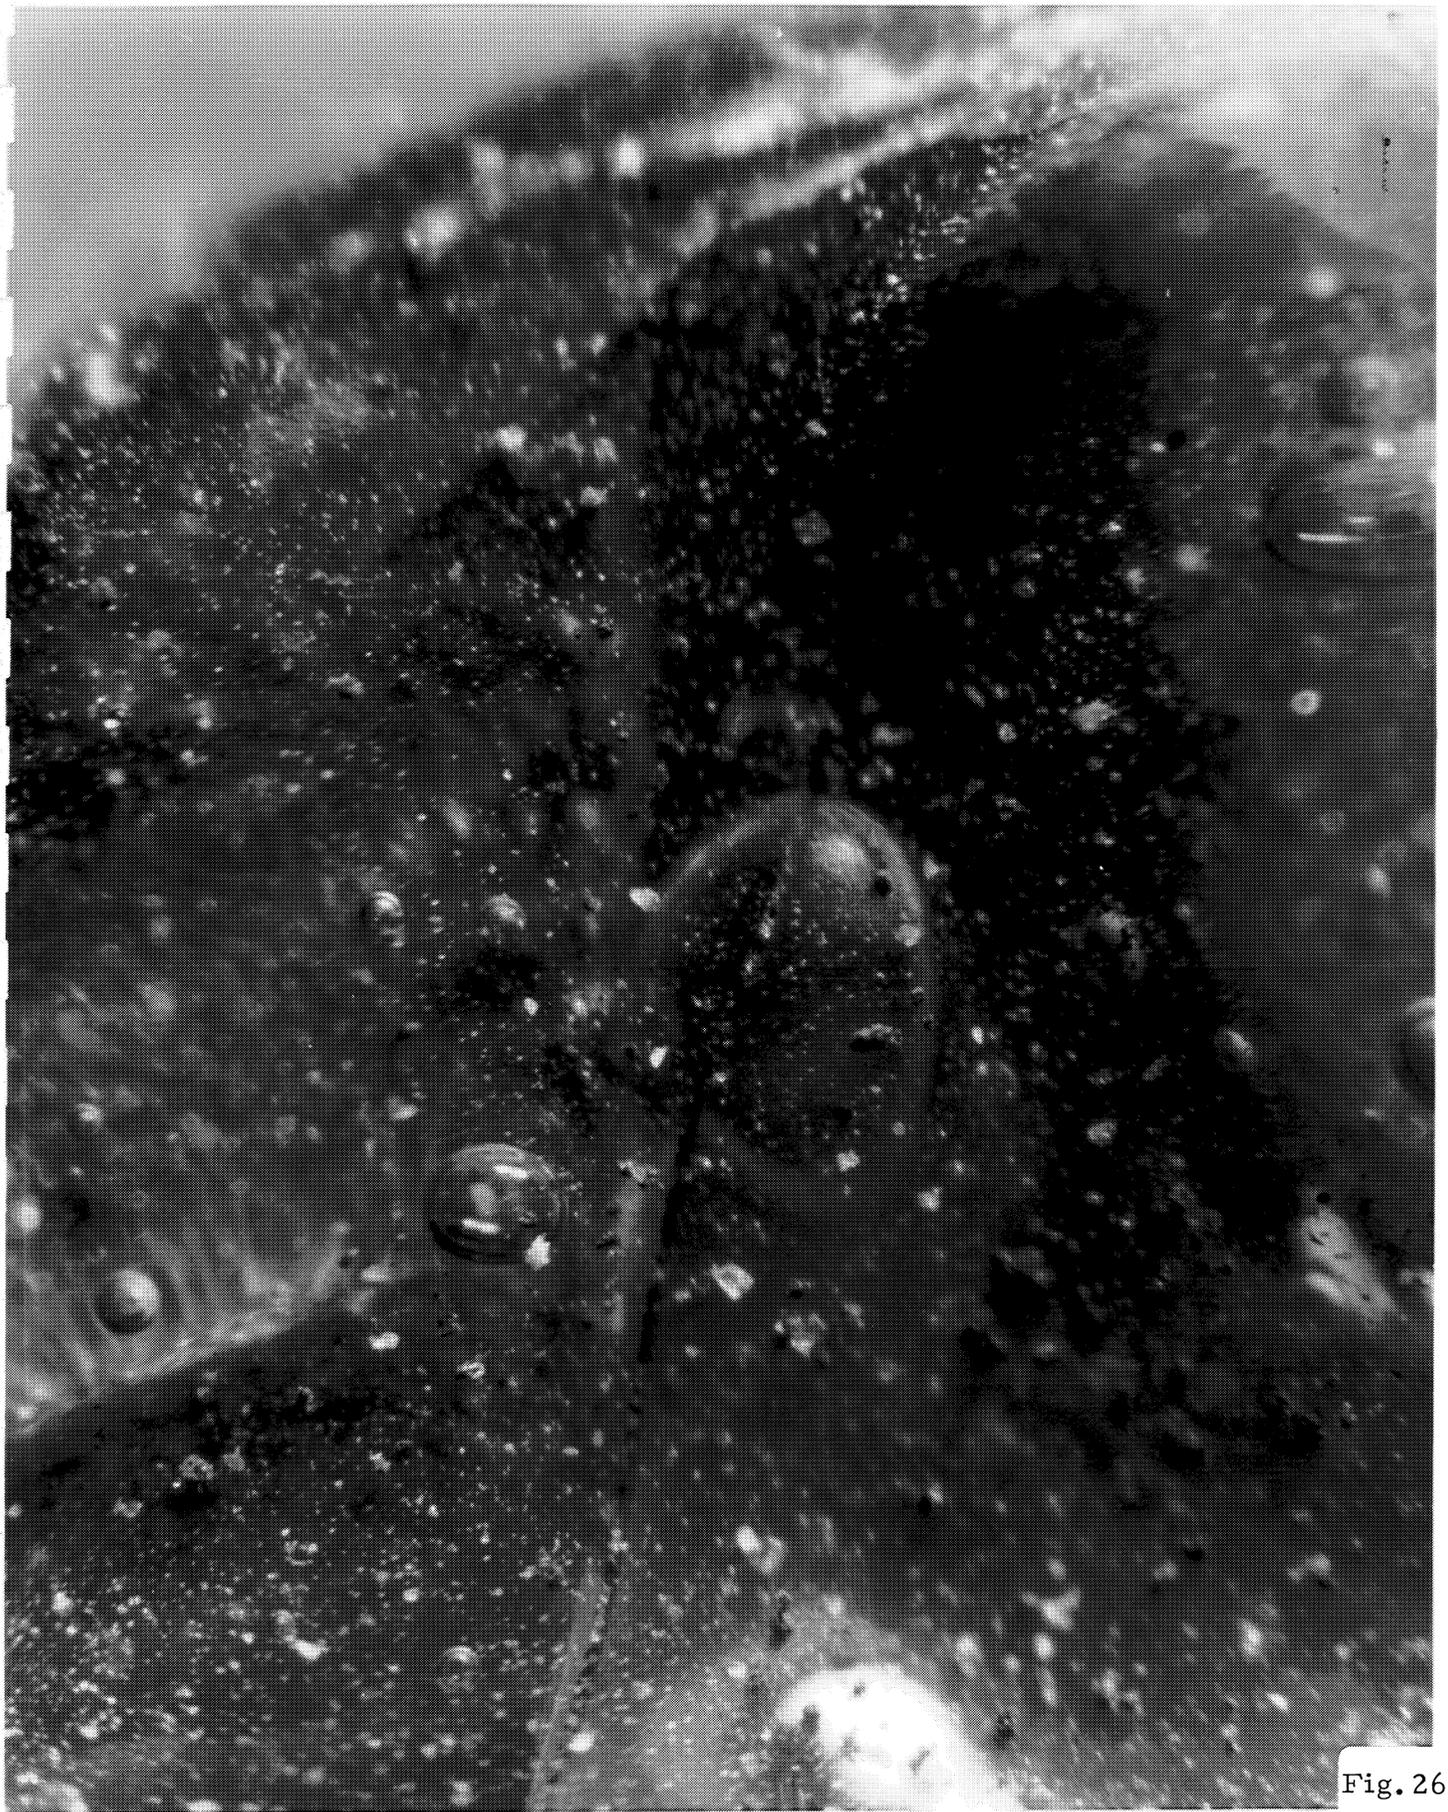
Fig. 26

The wires to the scoop door motor were attached to terminals on the scoop as can be seen, for instance, in Fig. 1 and Fig. 21. These connections were covered with a clear epoxy plastic to protect them. The present appearance of the plastic covering one of these terminals is shown in Fig. 26. This photograph indicates that the epoxy material has changed from its originally water-clear state to a yellow-amber color. A number of bubbles are apparent in the picture. They were probably included when the epoxy was cast originally. A crack reaching to the surface runs through the epoxy in the center of the picture; it is not, of course, known if it was originally present or not. It appears to bear some relation to the large bubble in the middle of the picture. The adhesion of particles of lunar soil to the epoxy surface is clearly seen in Fig. 26.
